# Fergus and Judith Basin Counties Remaining Prospects

Final Report  
Abandoned Mine Reclamation Project

## FERGUS AND JUDITH BASIN COUNTIES REMAINING PROSPECTS ABANDONED MINE RECLAMATION PROJECT

Robert Peccia & Associates, Inc.  
Helena, MT

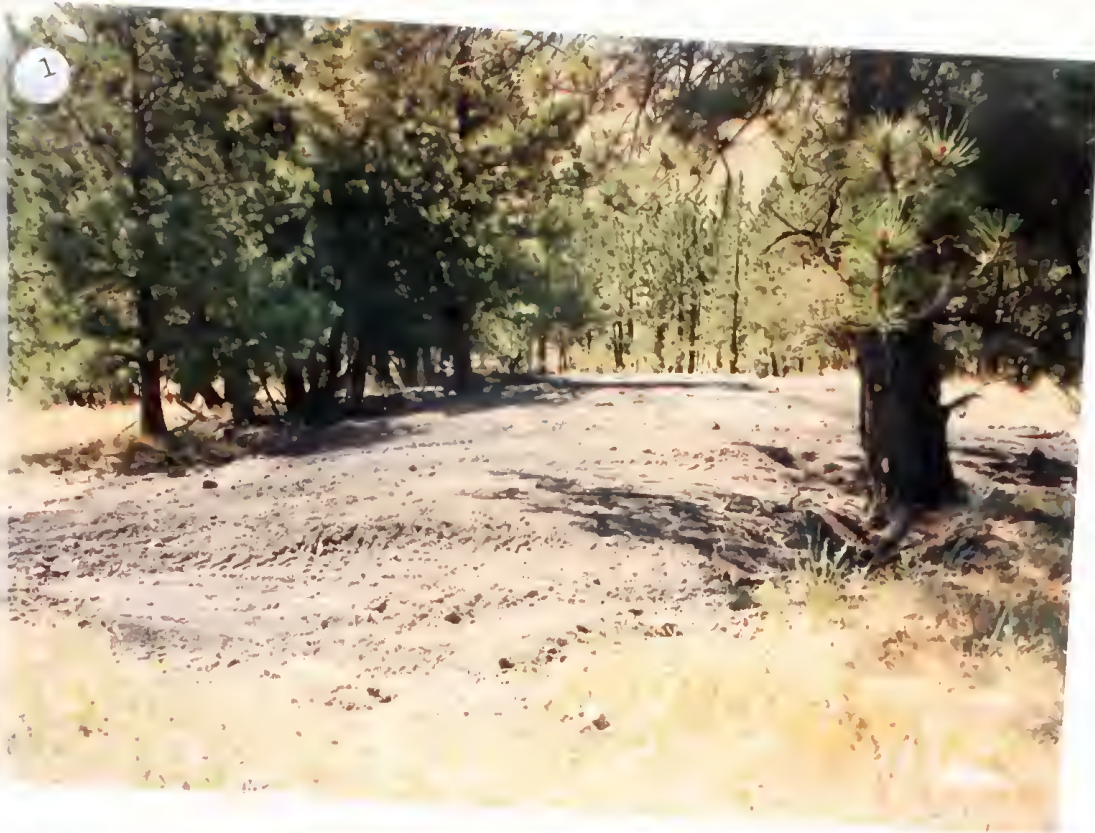
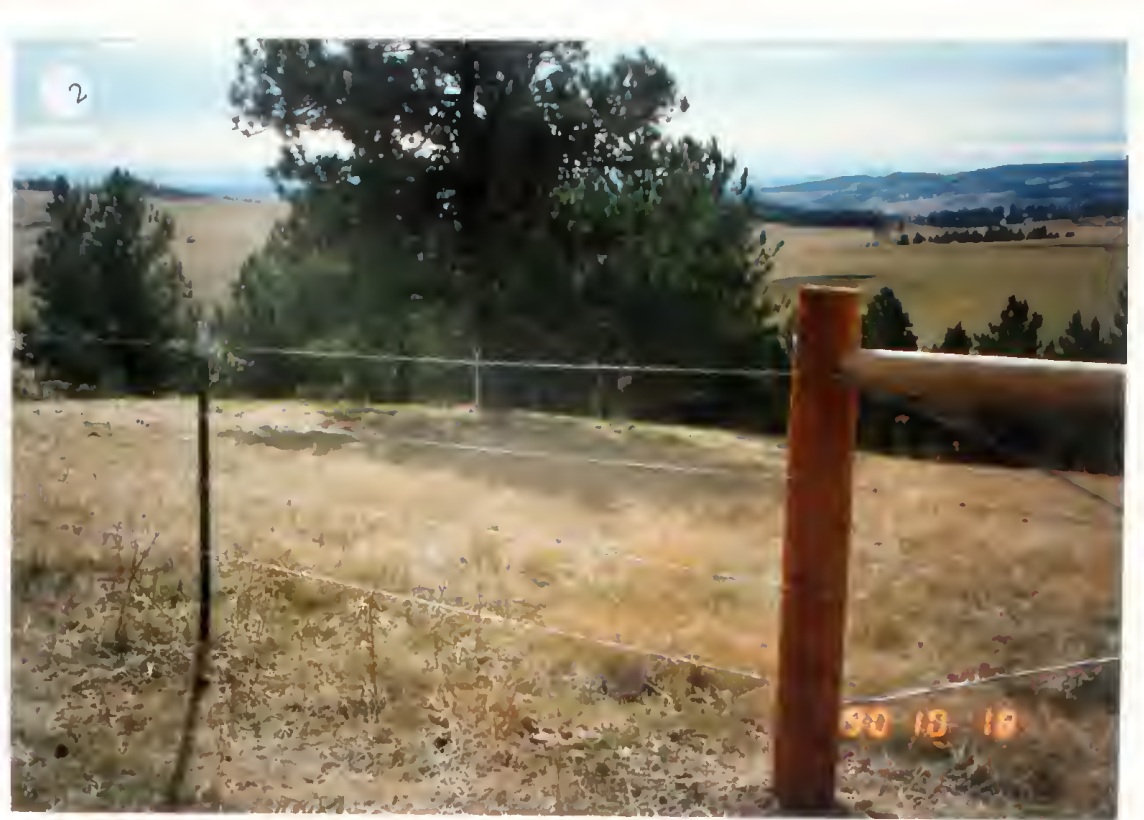
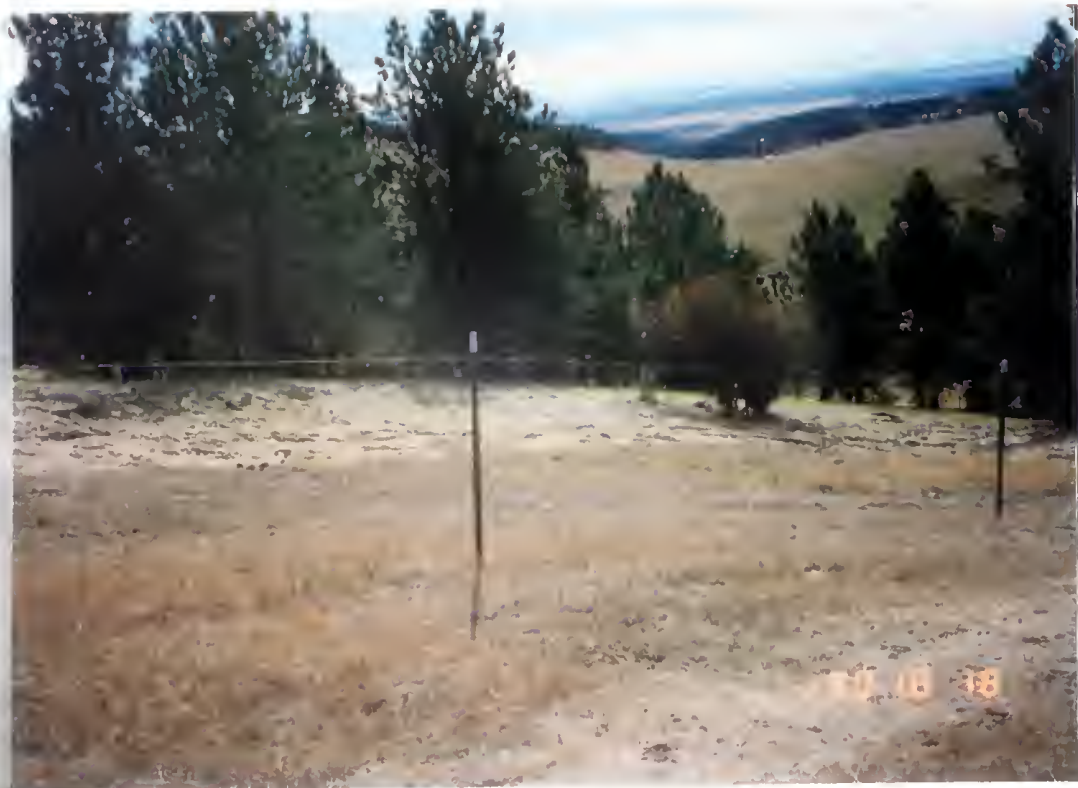
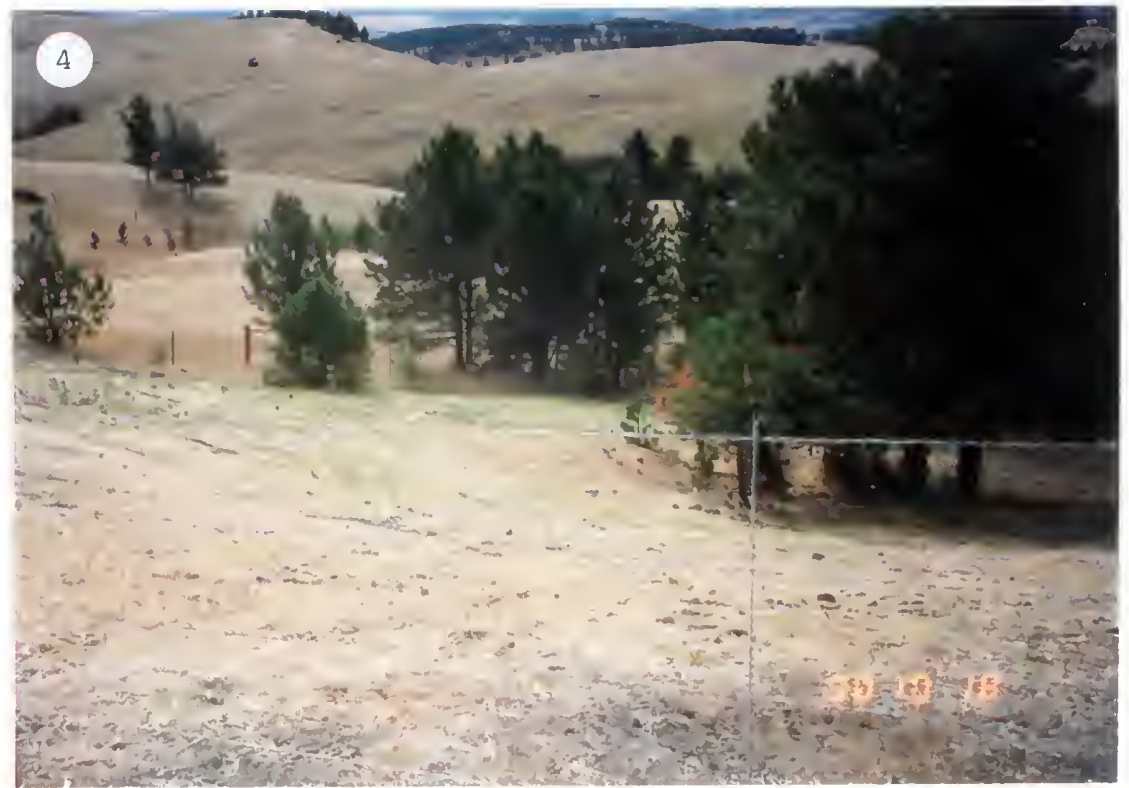
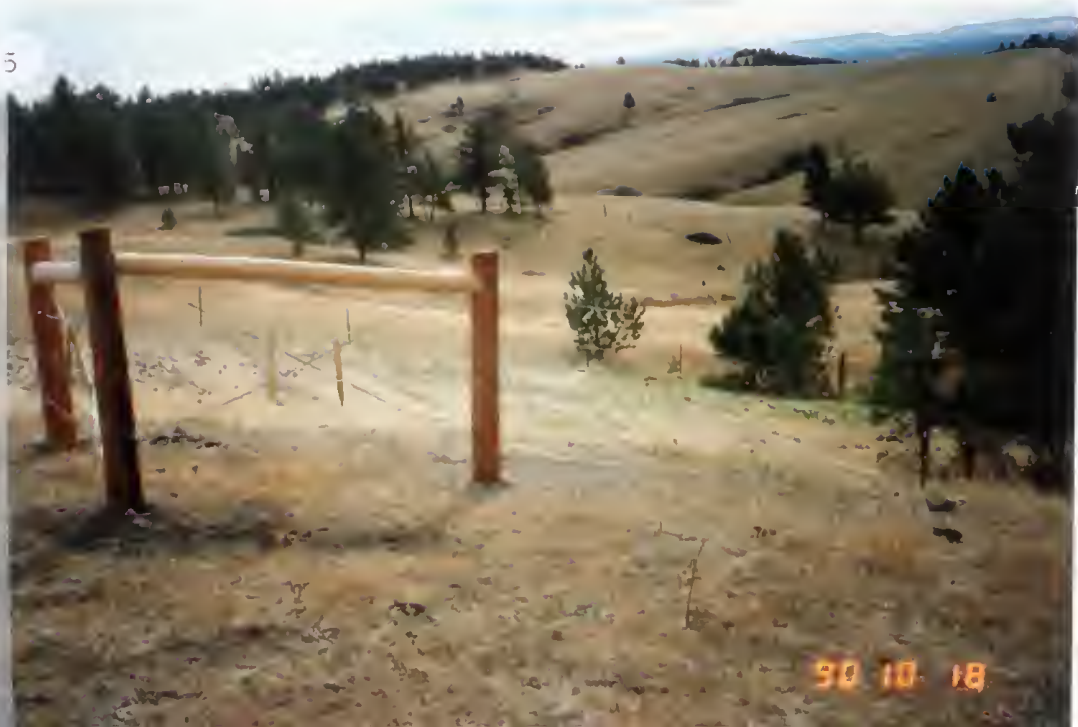
1. Shearson/Shipley Mines - Middle Site Before Reclamation
2. Shearson/Shipley Mines - Middle Adit During Exploration
3. Shearson/Shipley Mines - Middle Site Lime Incorporation
4. Shearson/Shipley Mines - West Site After Lime Incorporation
5. Shearson/Shipley Mines - West Site After Lime Incorporation

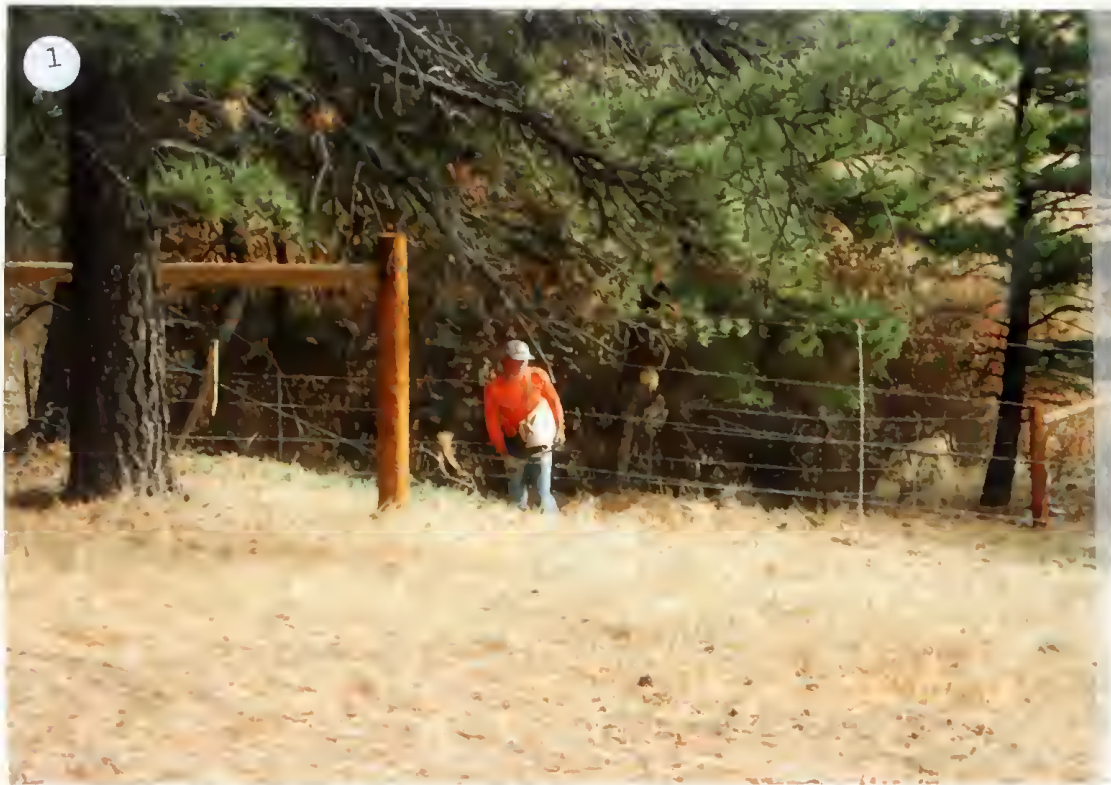
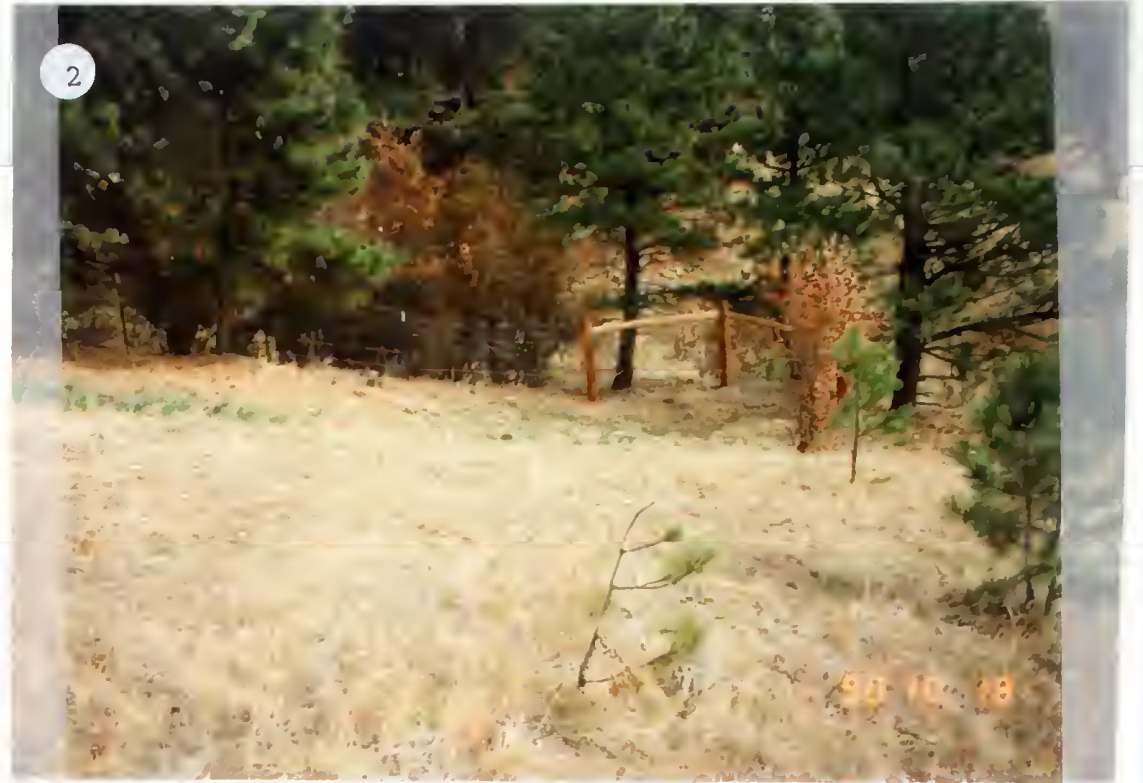
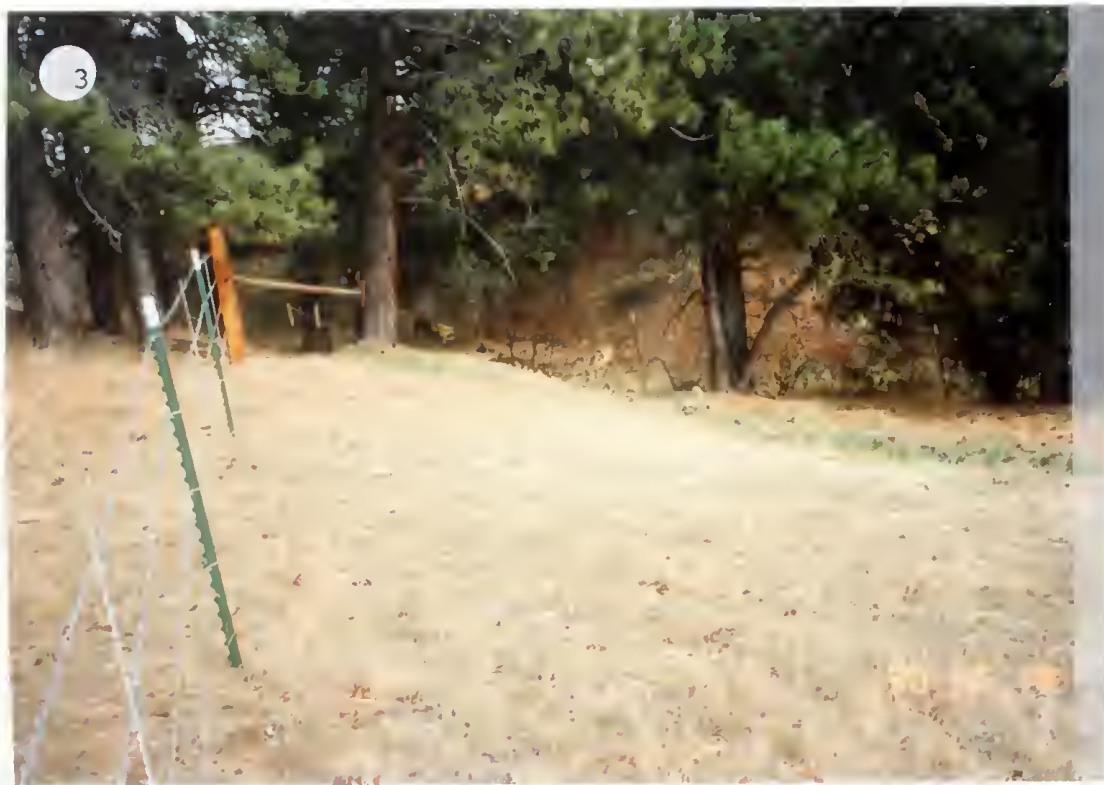
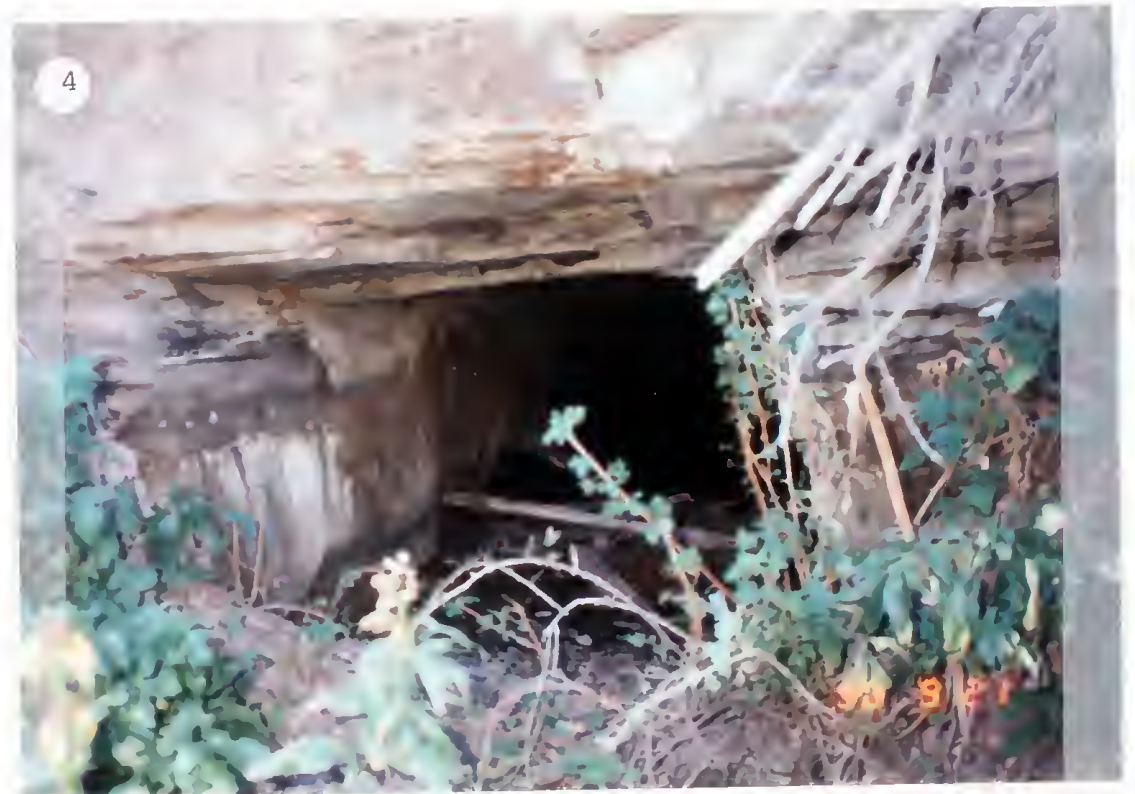
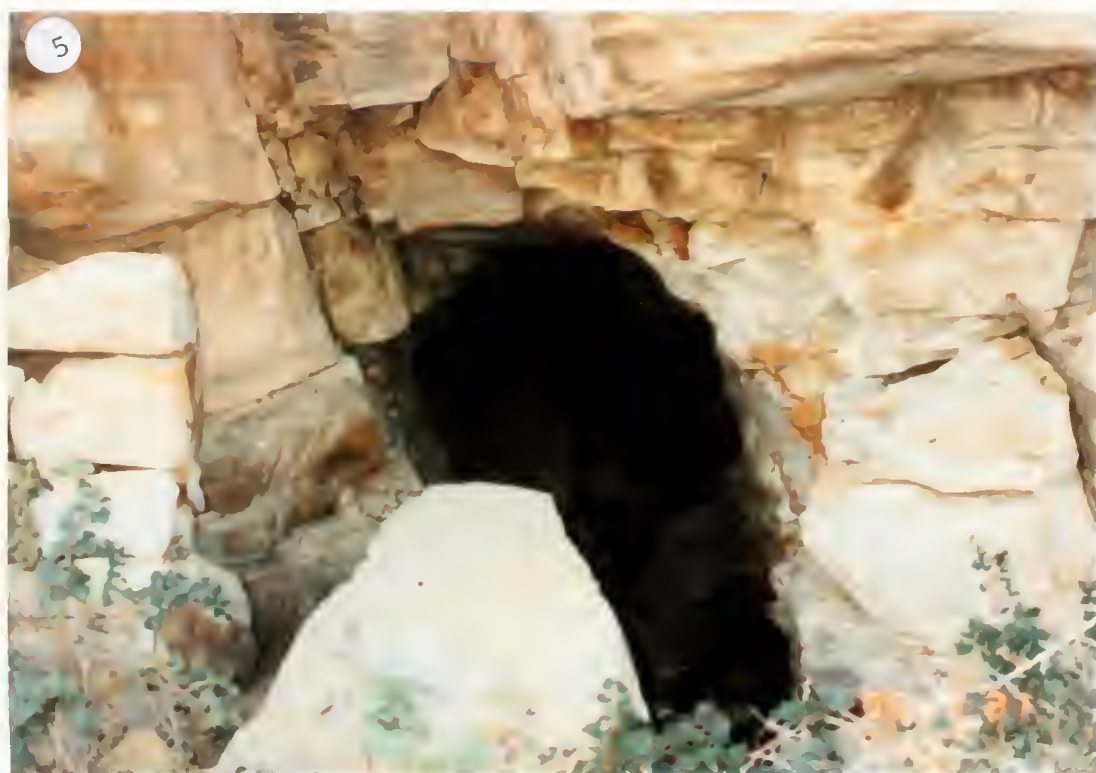
1. Shearson/Shipley Mines - West Site After Coversoiled
2. Shearson/Shipley Mines - West Site After Reclamation
3. Shearson/Shipley Mines - West Site After Reclamation
4. Shearson/Shipley Mines - Middle Site After Reclamation
5. Shearson/Shipley Mines - Middle Site After Reclamation

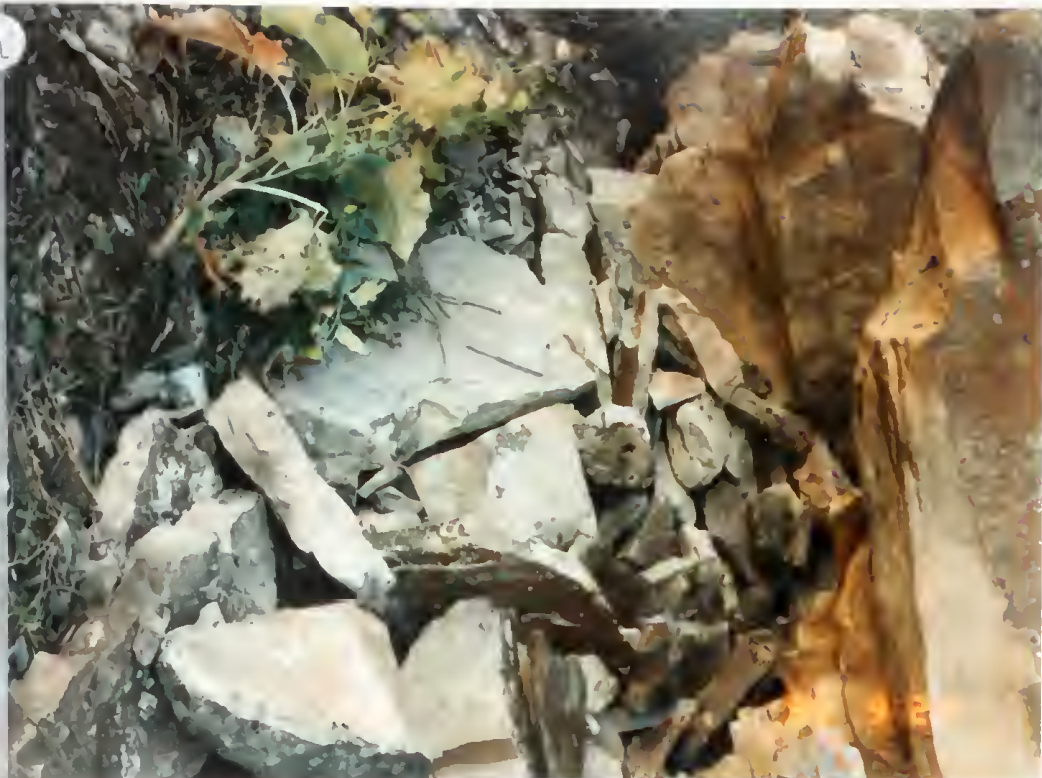
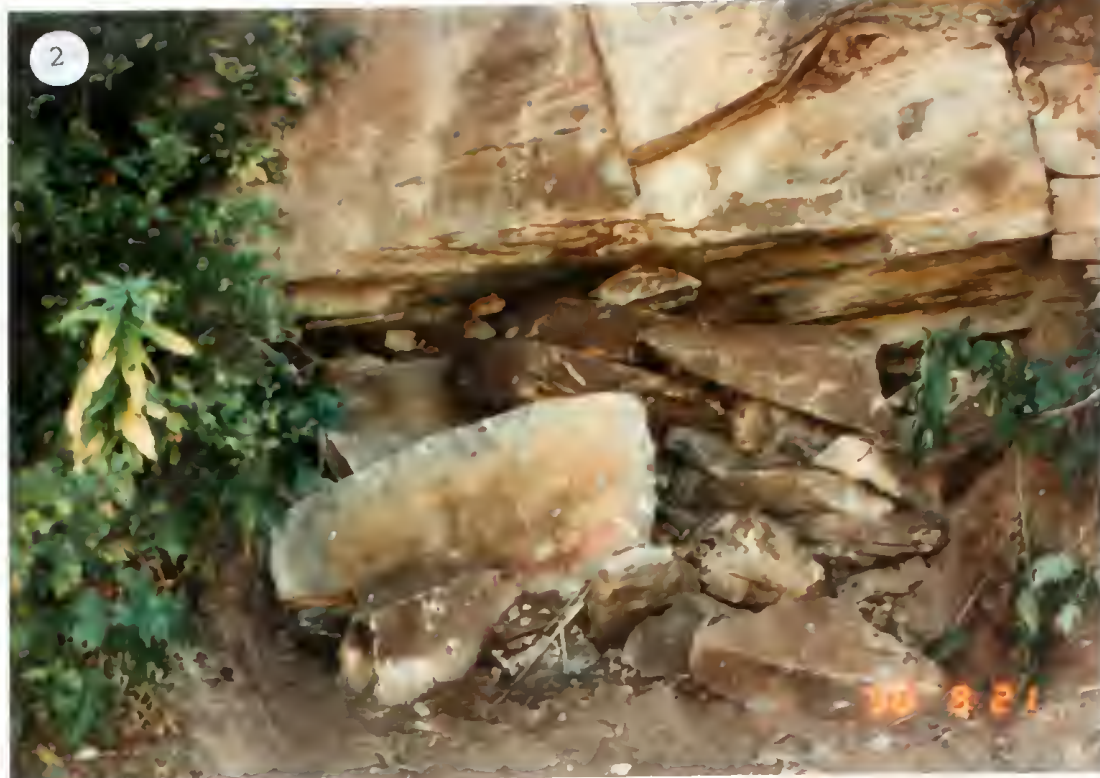
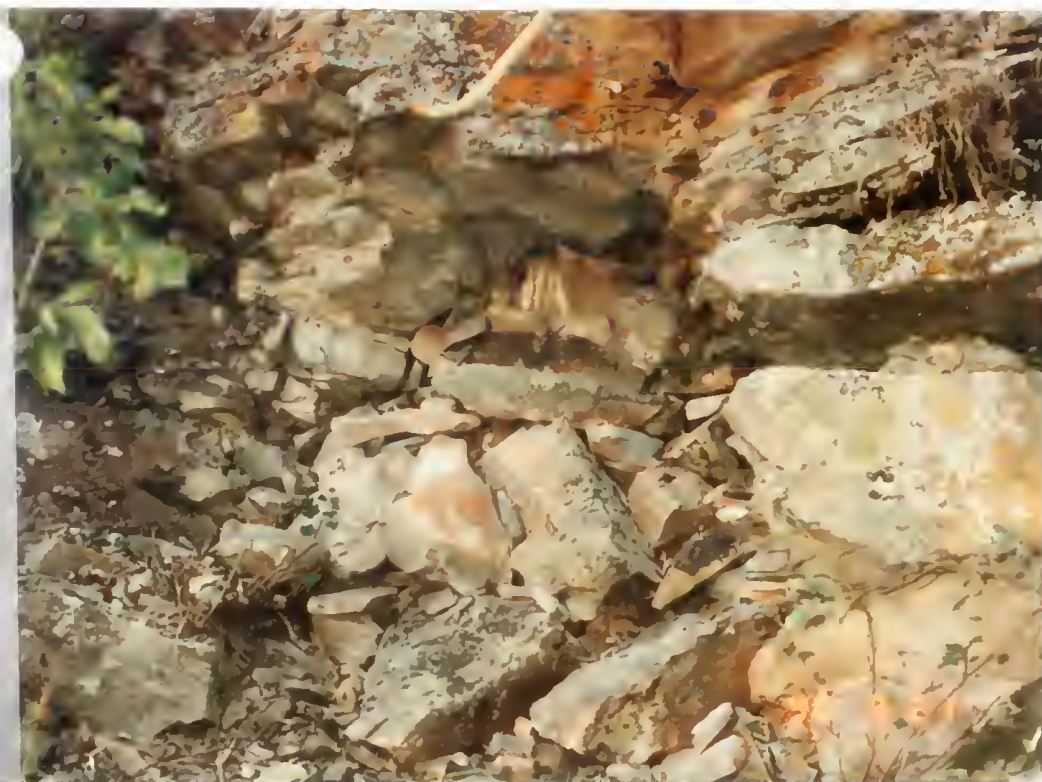
1. Larson Mines - East Adit After Closure
2. Larson Mines - Middle Adit After Closure
3. Larson Mines - West Adit After Closure

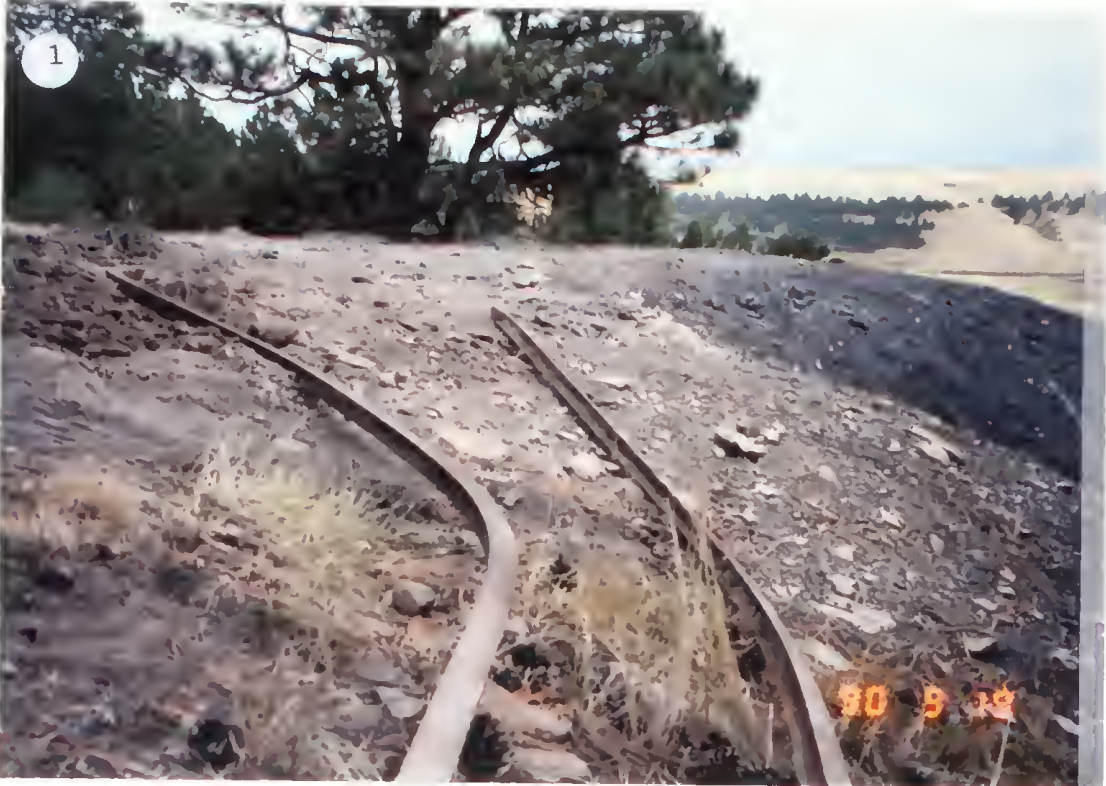
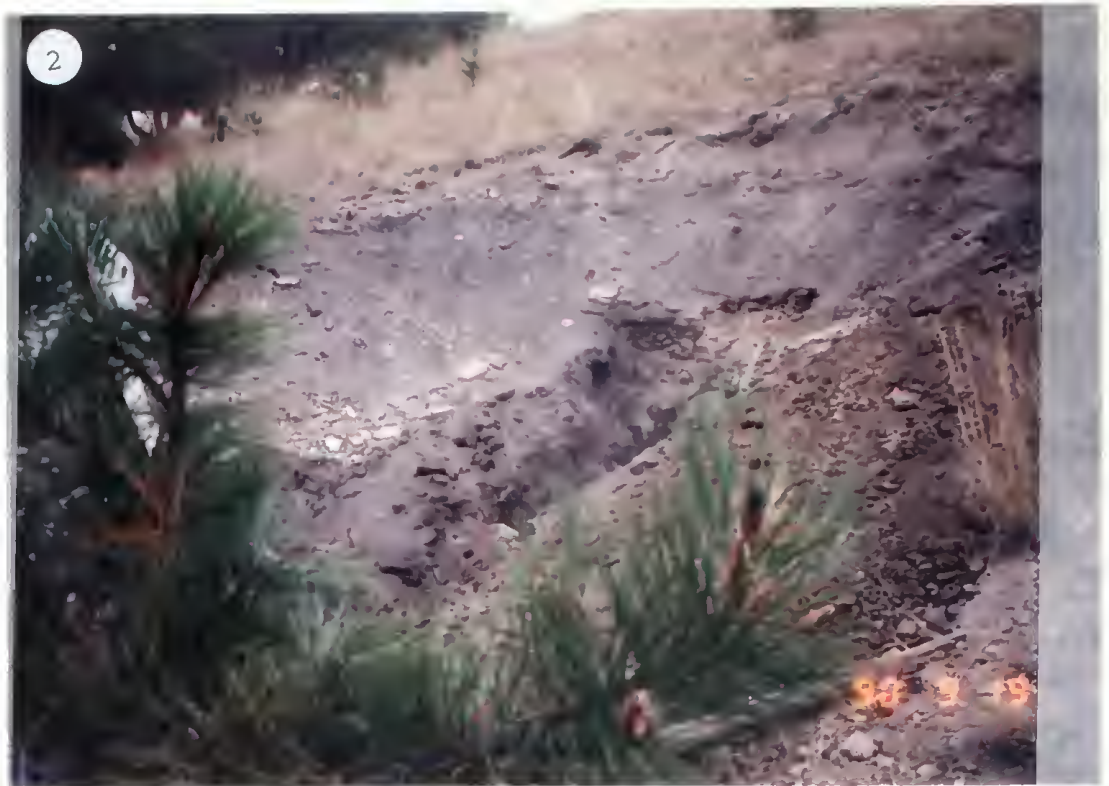
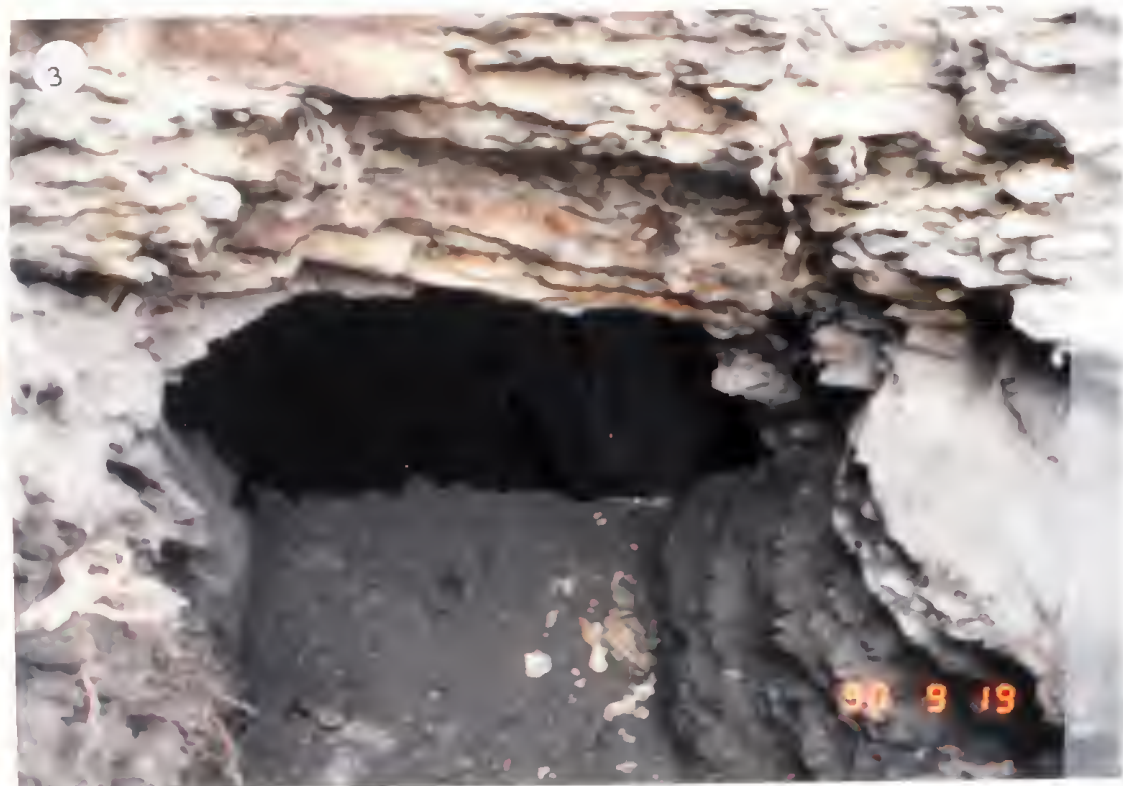
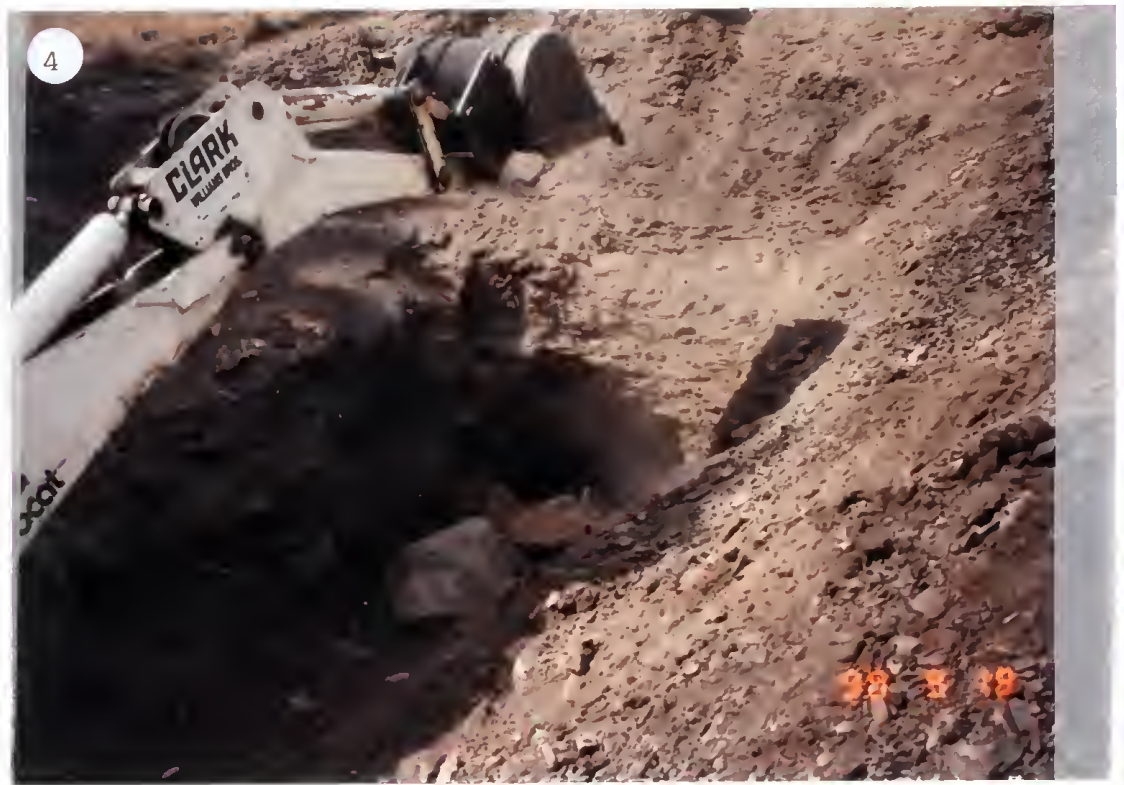
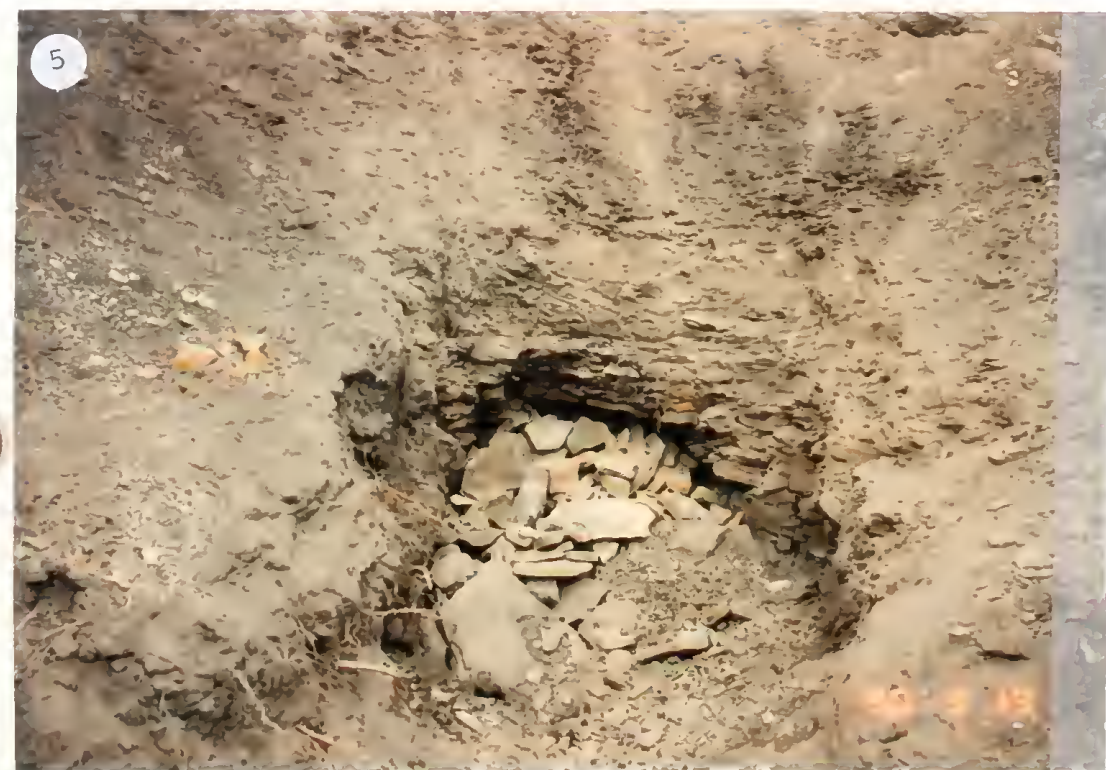
1. Ward Mine - Before Construction
2. Ward Mine - Adit Exploration
3. Ward Mine - Adit Opened During Exploration
4. Ward Mine - Adit Closure
5. Ward Mine - Adit Closure

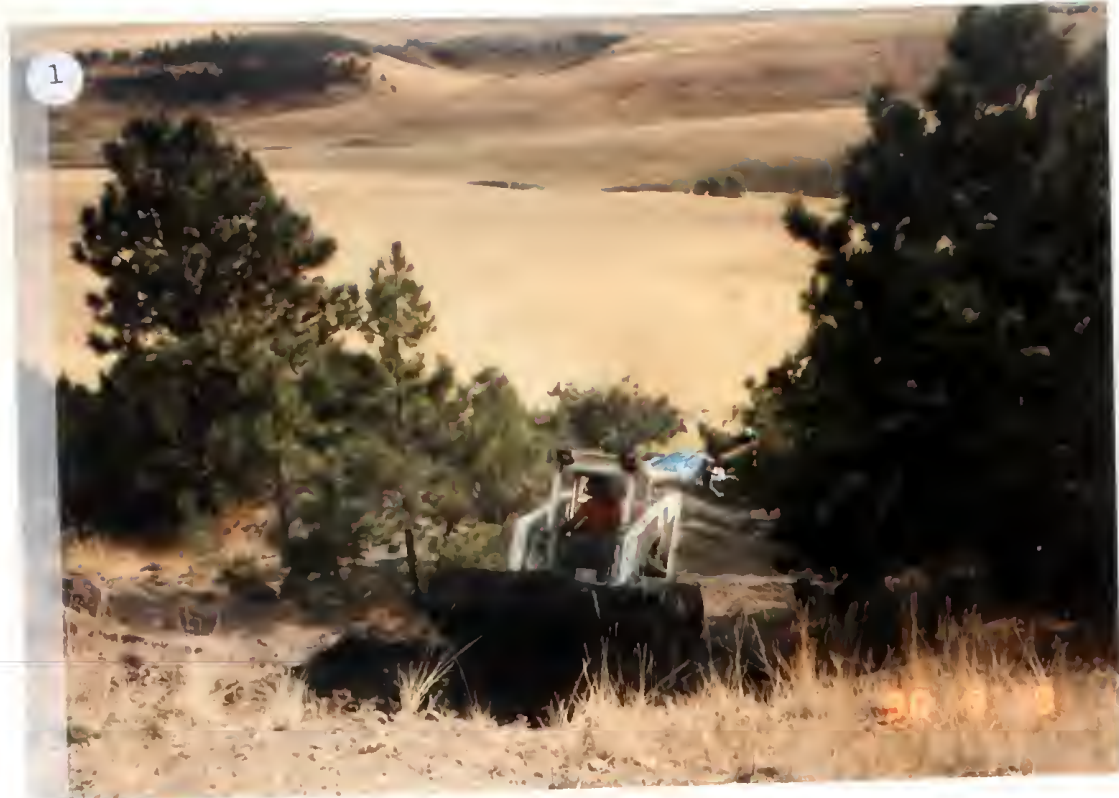
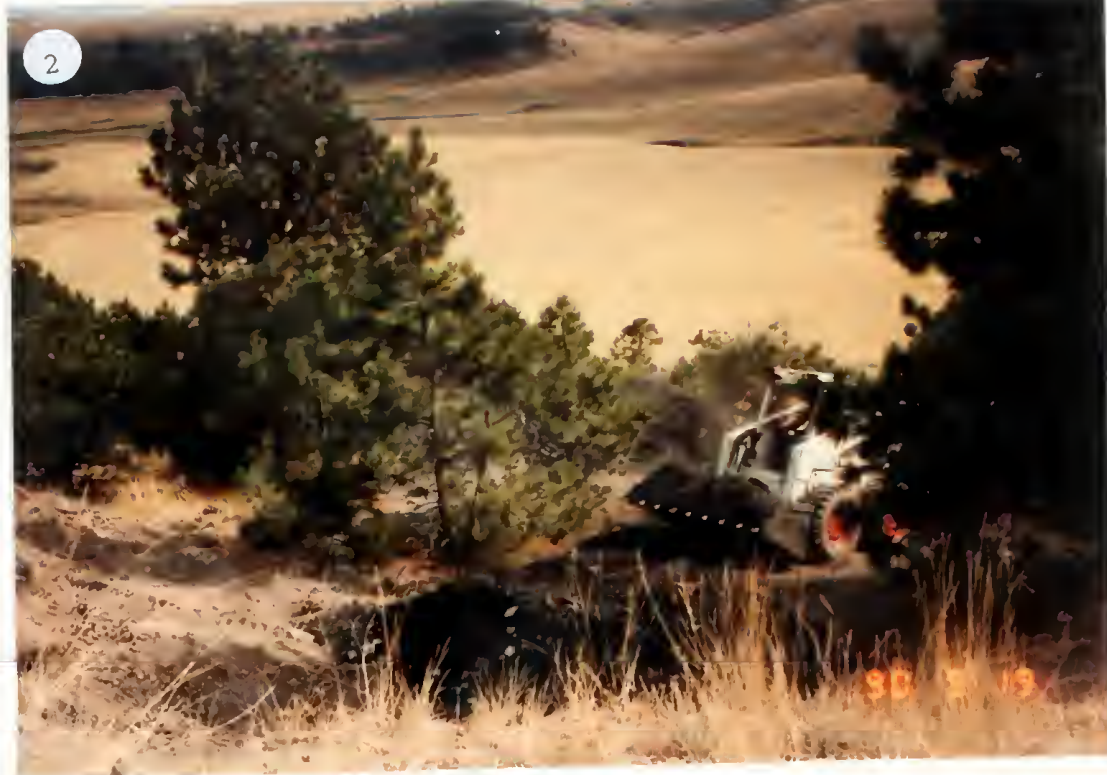
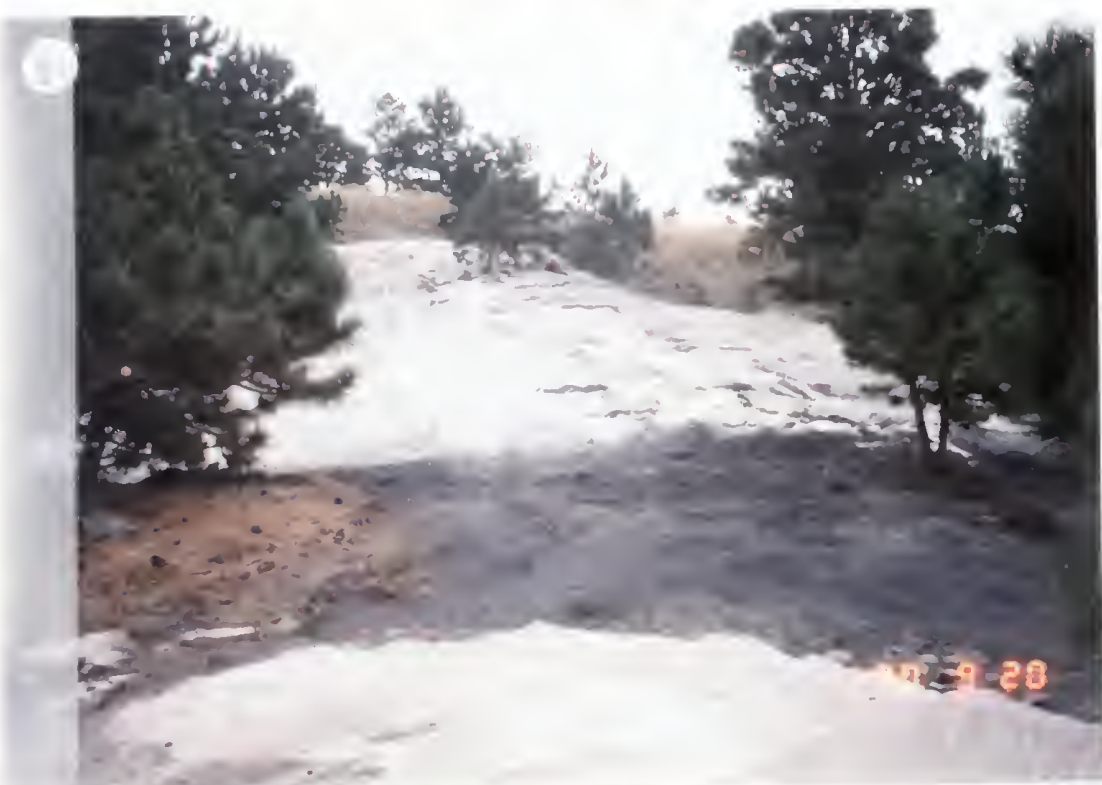
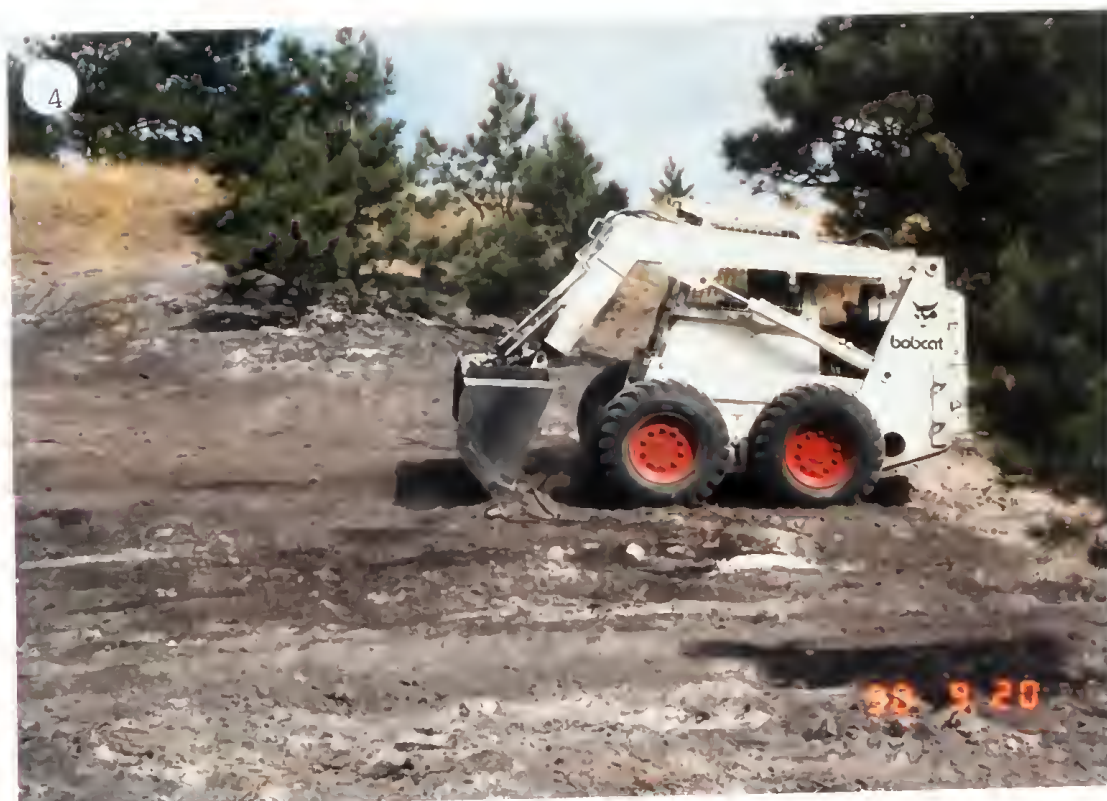
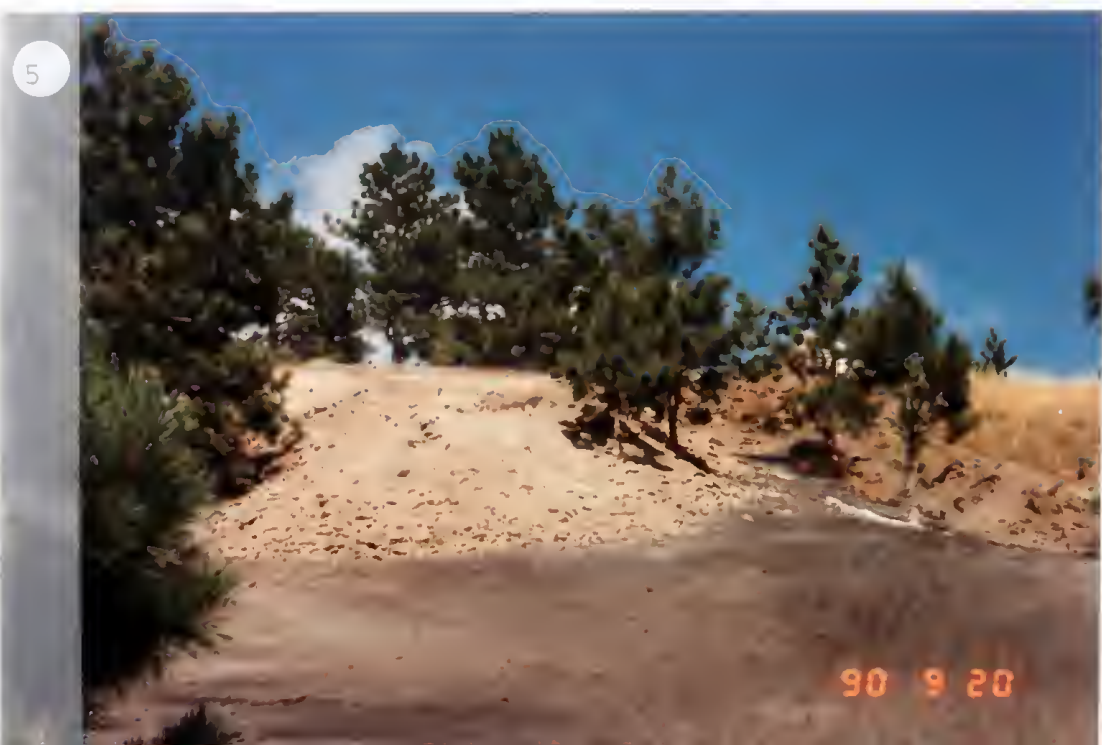
1. Ward Mine - Spoils Deposition
2. Ward Mine - Spoils Deposition
3. Ward Mine - Lime Application
4. Ward Mine - Lime Incorporation
5. Ward Mine - Coversoil Spreading
